SIB 64 01 24

2024-02-20

RYTHMIC DRUM NOISE HEARD FROM HVAC

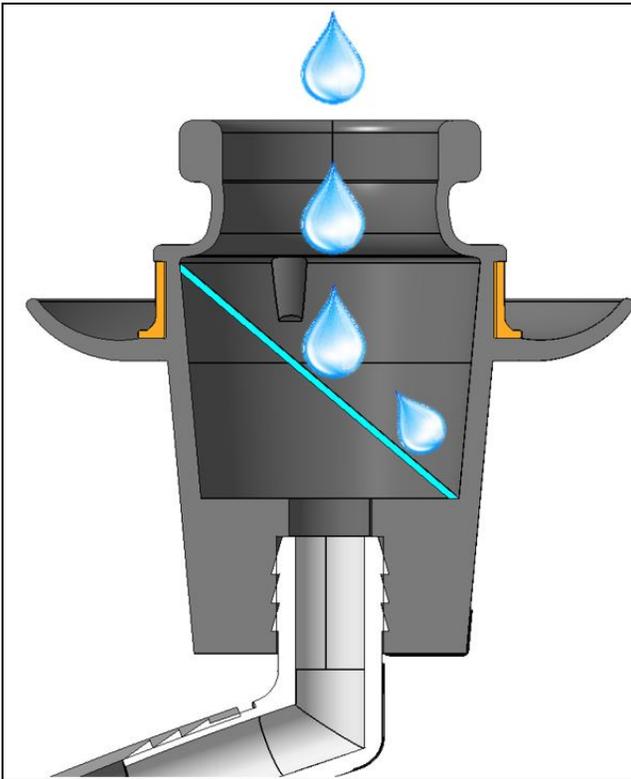
A ramp insert has been placed into the condensation drain plug, so the water drops falling into the condensate drain pipe are broken up- eliminating the drumming noise.

For vehicles produced prior to December 2023, replace the condensation water drain (shown here in dark grey).

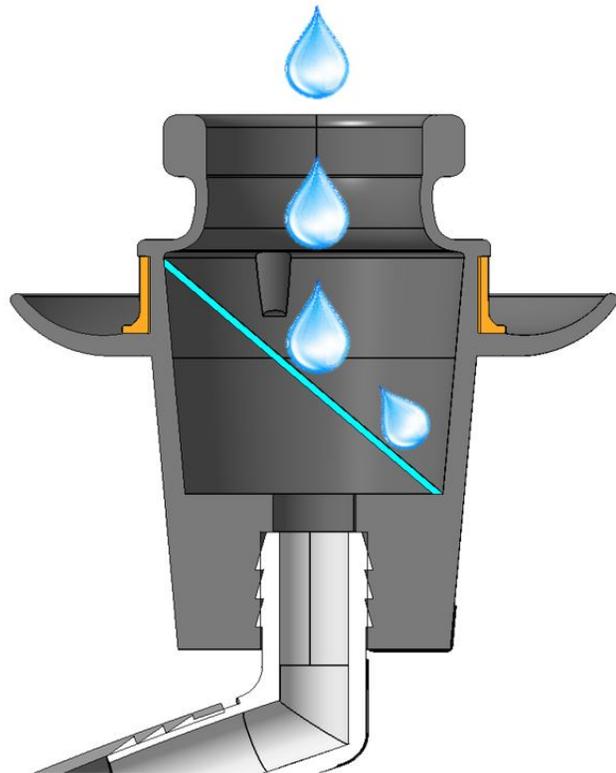
The condensation drain has been optimized and can be identified by a **WHITE DOT** or revision **INDEX 02** or higher.
