SIB 34 04 23

RECALL 24V-104: INTEGRATED BRAKE SYSTEM (IB)

This Service Information Bulletin (Revision 6) replaces SI B34 04 23 **dated March 2024**.

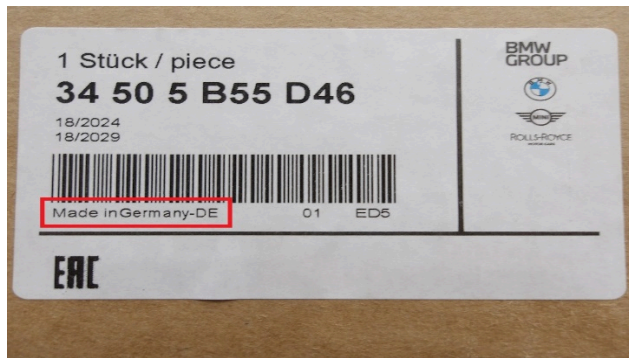
Determine the country of manufacturer of the component. If made in the USA proceed with the installation.

The following process only applies to service parts from production “Made in Germany DE” as shown in the red box on the parts label.

Inspection procedure applies to the service parts **without** a green dot on the label and IB.

Note: Label photo is example showing manufacturing location and may not reflect the part number you received.

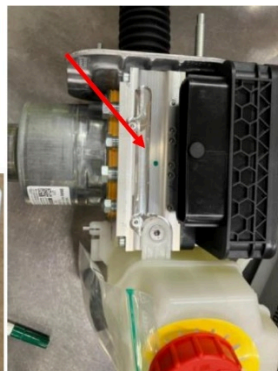
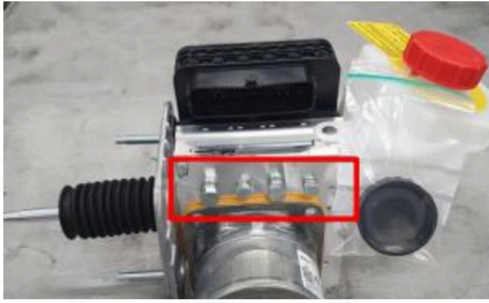
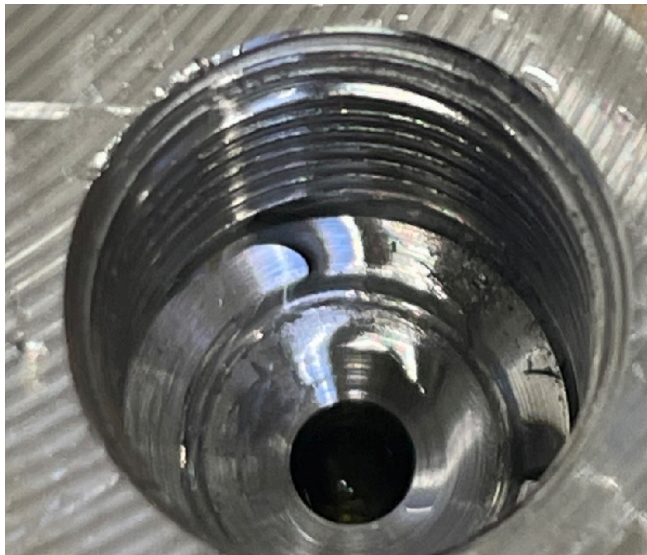
Replacement Part WITH a Green Dot

When the part has a “green dot” on the label and on the part itself, as indicated by the red arrows shown in the pictures; **the part has already been checked and is OK for use.**

If there is no “green dot,” proceed to the next step.

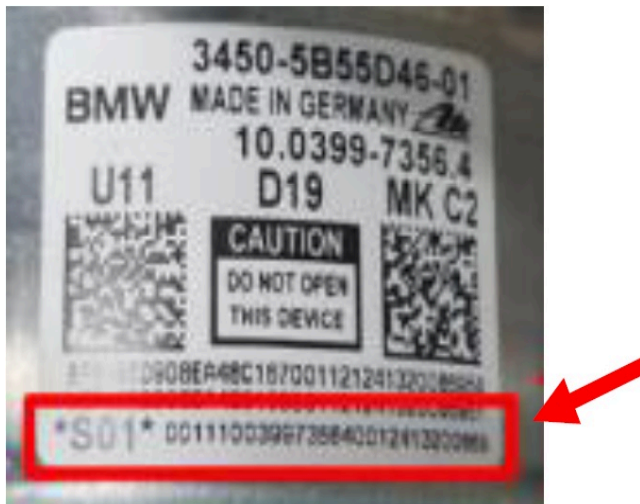
For parts that are not OK, torque higher than indicated value, thread damage or metallic particles inside:

- All plugs must be installed and tightened to 10 Nm to avoid leakage in the return process
- Claim the not OK part via the normal parts claim procedure using YR26
- Put TECIBS and the serial number in the comments field
- Claim the part failure with description defined tripping torque exceeded or

- optical damage or contamination has been detected in the connection
- If the part was found to have good torque values but optical contaminations (thread area), please attach photos of the damage/contamination and identify which hole this defect was found
- Re-open the Recall IDS Ticket with the Claim number and a replacement part will be ordered for you
